PIC24FJ256GA110 FAMILY

PIC24FJ256GA110 Family Silicon Errata and Data Sheet Clarification

The PIC24FJ256GA110 family devices that you have received conform functionally to the current Device Data Sheet (DS39905E), except for the anomalies described in this document.

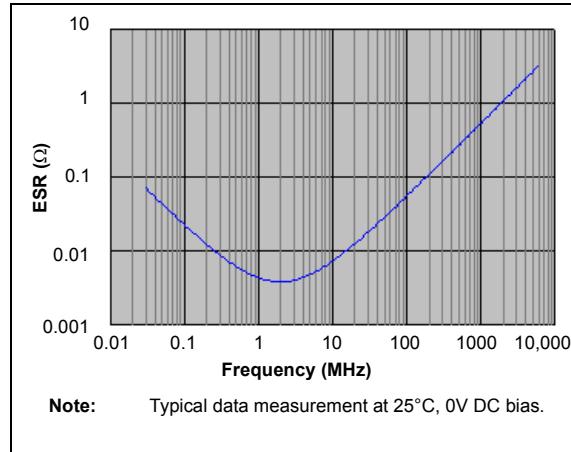
FIGURE 2-3 FREQUENCY vs. ESR PERFORMANCE FOR SUGGESTED VCAP

The placement of this capacitor should be close to VCAP/VDDCORE. It is recommended that the trace length not exceed 0.25 inch (6 mm). Refer to **Section 28.0 “Electrical Characteristics”** for additional information.

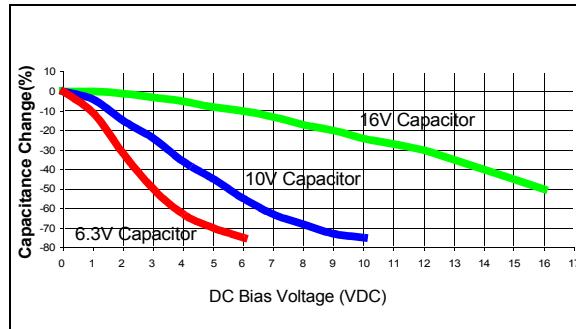
FIGURE 2-4

**DC BIAS VOLTAGE vs.
CAPACITANCE
CHARACTERISTICS**

When selecting a ceramic capacitor to be used with the internal voltage regulator, it is suggested to select a high-voltage rating, so that the operating voltage is a small percentage of the maximum rated capacitor voltage. For example, choose a ceramic capacitor rated at 16V for the 2.5V core voltage. Suggested capacitors are shown in [Table 2-1](#).
